Tornado and Windstorm Damage Assessment

Rainer Kaltenberger

EUMeTrain Wind Event Week – March 1st, 2022

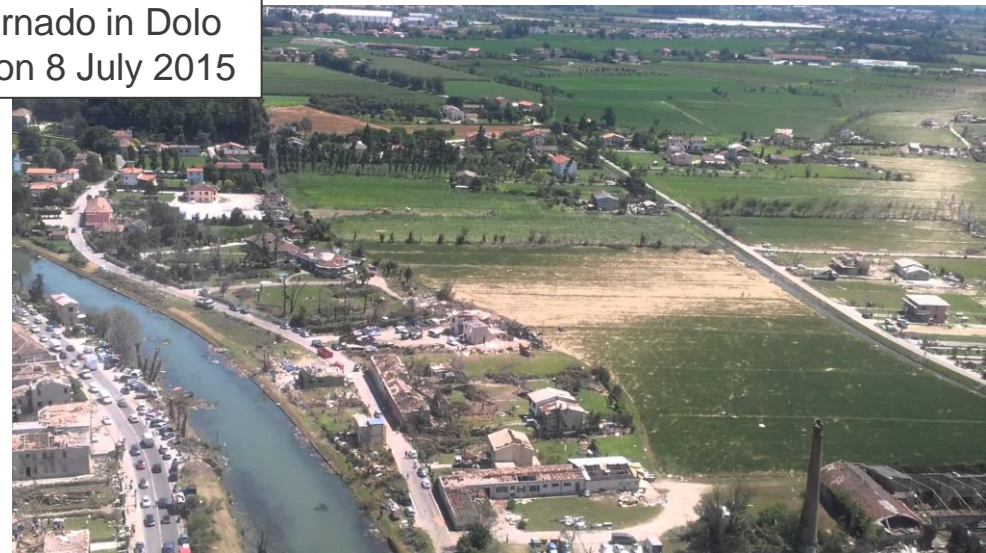
Example: tornado in Dolo (Veneto, IT) on 8 July 2015

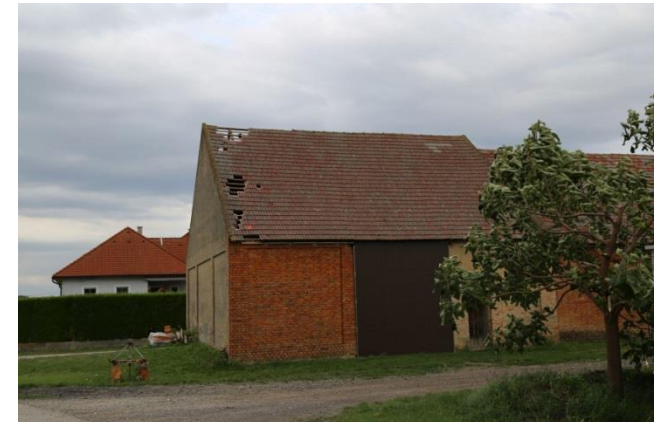
DI-DoD method: Adaptation of „Damage Indicators“ for Europe

Fujita damage class		f0	f1	f2	f3	f4	f5
loss ratio (%)		0.1	1	10	50	90	100
degree of damage → damage indicator ↓		light roof damage	significant roof damage	roof gone	walls partly collapsed	largely blown down	blown away
A	weakest outbuilding	F0+	F0+	F1-	F1-	F1+	F2-
	outbuilding	F0+	F1-	F1+	F2-	F2+	F3-
	strong outbuilding/ weak framehouse	F0+	F1+	F2-	F3-	F3+	F4-
	weak brick structure/ strong framehouse	F1-	F1+	F2+	F3+	F4-	F5
	strong brick structure	F1-	F2-	F3-	F4-	F5	F5
	concrete building	F1-	F2+	F3+	F4+	F5	F5

A ... like a doghouse or unanchored light outbuildings
 B ... like huts and barns, anchored light outbuildings
 C ... like the typical US-midwest framehouses, if weakly anchored/connected to the foundation
 D ... like the typical US-midwest framehouses, if well anchored and connected. I Europe typically single-row brick structures (mainly 2-dimensional single-row brick walls – like garden walls – fall into B or C). This category best corresponds to the original Fujita-scale.
 E ... the typical central European masonry house
 F ... steel-reinforced concrete buildings. Some historic fort-like buildings (castles) and some Mediterranean-style buildings in wind-prone-areas (like in Dalmatia) also fall into this category with their extremely thick stone-walls (if well-built and kept renovated).

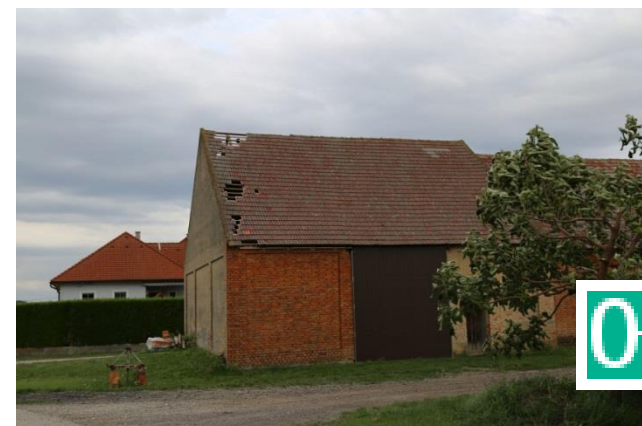
DI-DoD method: Adaptation of „Damage Indicators“ for Europe

Fujita damage class		f0	f1	f2	f3	f4	f5
loss ratio (%)		0.1	1	10	50	90	100
degree of damage → damage indicator ↓		light roof damage	significant roof damage	roof gone	walls partly collapsed	largely blown down	blown away
A	weakest outbuilding	F0+	F0+	F1-	F1-	F1+	F2-
	outbuilding	F0+	F1-	F1+	F2-	F2+	F3-
	strong outbuilding/ weak framehouse	F0+	F1+	F2-	F3-	F3+	F4-
	weak brick structure/ strong framehouse	F1-	F1+	F2+	F3+	F4-	F5
	strong brick structure	F1-	F2-	F3-	F4-	F5	F5
	concrete building	F1-	F2+	F3+	F4+	F5	F5

C ... like the typical US-midwest framehouses, if weakly anchored/connected to the foundation

E ... the typical central European masonry house

F ... steel-reinforced concrete buildings. Some historic fort-like buildings (castles) and some Mediterranean-style buildings in wind-prone-areas (like in Dalmatia) also fall into this category with their extremely thick stone-walls (if well-built and kept renovated).

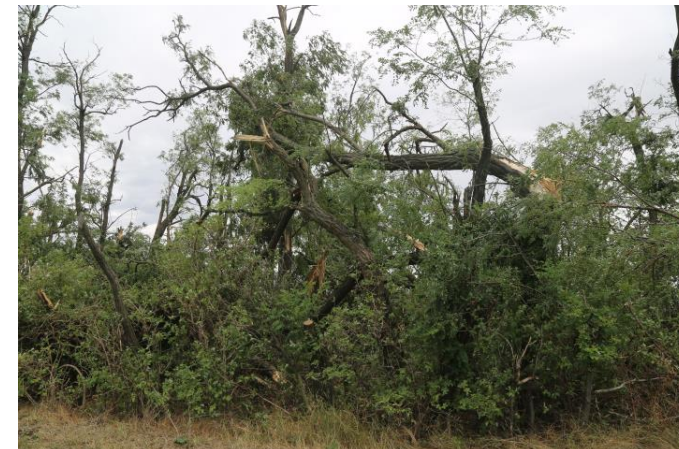
DI-DoD method: Adaptation of „Damage Indicators“ for Europe

• Part 2: Vegetation

Fujita damage class	f0	f1	f2	f3	f4	f5
	loss ratio (%)	0.1	1	10	50	90	100
	damage prevalence → damage indicator ↓	extremely isolated	isolated	significant	frequent	prevalent	total
G	branches - leafy	< F0	F0+	F1-	F1+	F2-	F3-
H	- bare	F0-	F1-	F1+	F2-	F2-	F3-
I	tree stands - diseased/ unstable	< F0	F0-	F0+	F0+	F1-	F1-
J	- strong	F0+	F1-	F1+	F1+	F2-	F2-
K	edge trees, hedges, underwood	F1-	F1+	F2-	F2+	F3-	F3-

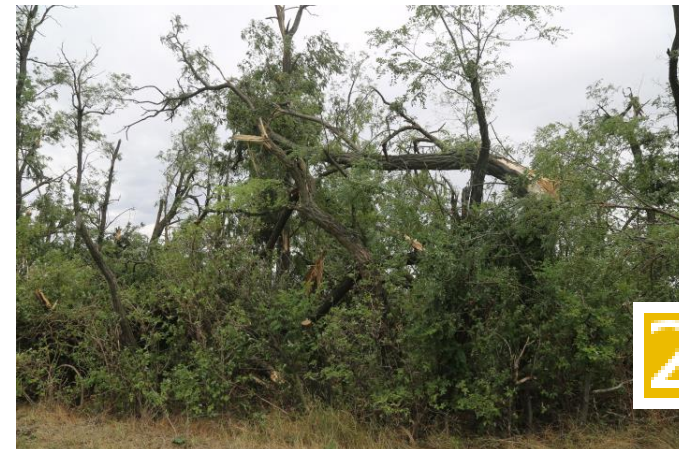
DI-DoD method: Adaptation of „Damage Indicators“ for Europe

• Part 2: Vegetation

Fujita damage class	f0	f1	f2	f3	f4	f5
	loss ratio (%)	0.1	1	10	50	90	100
	damage prevalence → damage indicator ↓	extremely isolated	isolated	significant	frequent	prevalent	total
G	branches - leafy	< F0	F0+	F1-	F1+	F2-	F3-
H	- bare	F0-	F1-	F1+	F2-	F2-	F3-
I	tree stands - diseased/ unstable	< F0	F0-	F0+	F0+	F1-	F1-
J	- strong	F0+	F1-	F1+	F1+	F2-	F2-
K	edge trees, hedges, underwood	F1-	F1+	F2-	F2+	F3-	F3-

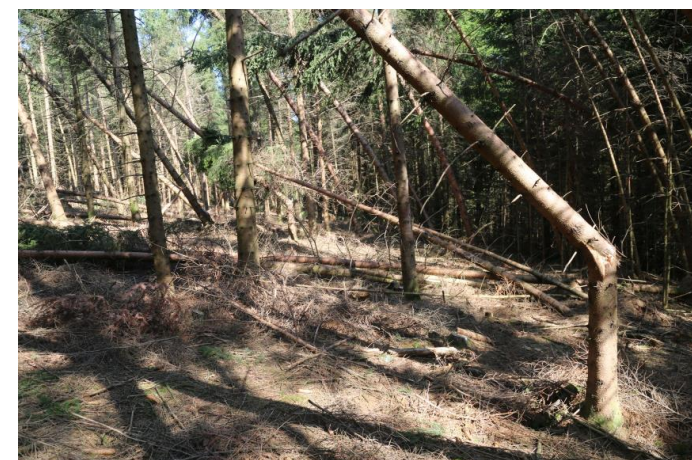
DI-DoD method: Adaptation of „Damage Indicators“ for Europe

• Part 2: Vegetation

Fujita damage class	f0	f1	f2	f3	f4	f5
	loss ratio (%)	0.1	1	10	50	90	100
	damage prevalence → damage indicator ↓	extremely isolated	isolated	significant	frequent	prevalent	total
G	branches - leafy	< F0	F0+	F1-	F1+	F2-	F3-
H	- bare	F0-	F1-	F1+	F2-	F2-	F3-
I	tree stands - diseased/ unstable	< F0	F0-	F0+	F0+	F1-	F1-
J	- strong	F0+	F1-	F1+	F1+	F2-	F2-
K	edge trees, hedges, underwood	F1-	F1+	F2-	F2+	F3-	F3-

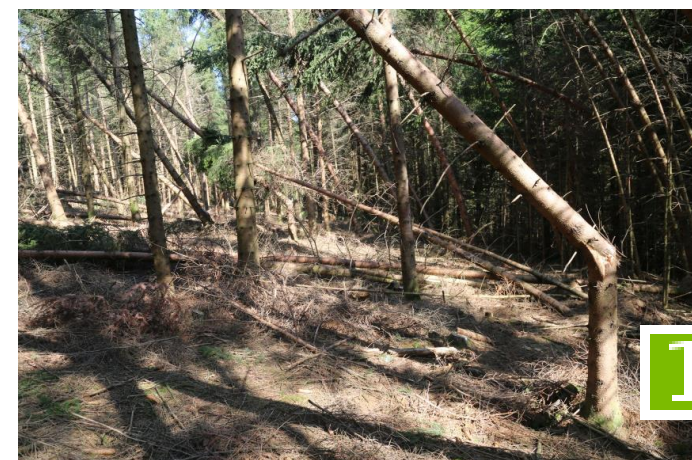
DI-DoD method: Adaptation of „Damage Indicators“ for Europe

• Part 2: Vegetation

Fujita damage class	f0	f1	f2	f3	f4	f5
	loss ratio (%)	0.1	1	10	50	90	100
	damage prevalence → damage indicator ↓	extremely isolated	isolated	significant	frequent	prevalent	total
G	branches - leafy	< F0	F0+	F1-	F1+	F2-	F3-
H	- bare	F0-	F1-	F1+	F2-	F2-	F3-
I	tree stands - diseased/ unstable	< F0	F0-	F0+	F0+	F1-	F1-
J	- strong	F0+	F1-	F1+	F1+	F2-	F2-
K	edge trees, hedges, underwood	F1-	F1+	F2-	F2+	F3-	F3-

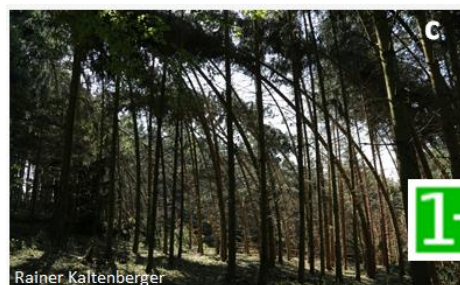
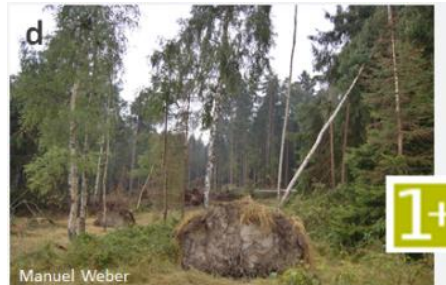
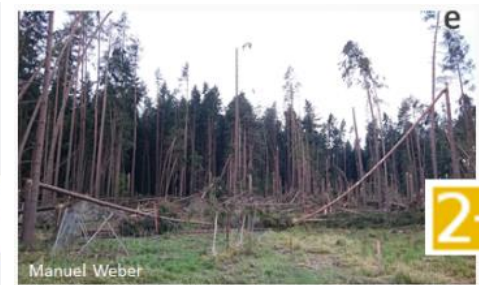
DI-DoD method: Adaptation of „Damage Indicators“ for Europe - vegetation

DI 1 - 10	DI Subdivision a - f	DoD 1	DoD 2	DoD 3	DoD 4	DoD 5	DoD 6	DoD 7
Type of Tree	Stability Parameters	small limbs and dead branches broken	strong branches and crown parts broken	uprooting or compression failure	uprooting or trunk snapping	intensive debranching or tearing out, transport of big tree parts	beginning of debarking due to "sandblast effect"	nearly total debarking due to "sandblast effect"
1 Oak	a - fragile ground AND unstable forest stands	lower F0	upper F0	lower F1	lower F1	upper F2	upper F3	≥F4
	b - average ground in combination with unstable stands OR vice versa	lower F0	upper F0	F1	F1	upper F2	upper F3	≥F4
	c - average ground, average stock	lower F0	upper F0	F1	lower F2	upper F2	upper F3	≥F4
	d - firm, rocky ground, stable forest stands, only trees with healthy wood	lower F0	upper F0	lower F2	lower F2	upper F2	upper F3	≥F4
	e - forest edge situation & firm ground, only trees with healthy wood	lower F0	F1	lower F2	F2	lower F3	upper F3	≥F4

c - average ground, average stock	lower F0	upper F0	lower F1	F1	lower F2	upper F3	≥F4
	d - firm, rocky ground, stable forest stands, only trees with healthy wood	lower F0	upper F0	F1	F1	lower F2	upper F3	≥F4
	e - forest edge situation & firm ground, only trees with healthy wood	lower F0	F1	F1	lower F2	upper F2	upper F3	≥F4
	f - solitary trees & firm ground, only trees with healthy wood	lower F0	F1	F1	lower F2	upper F2	upper F3	≥F4

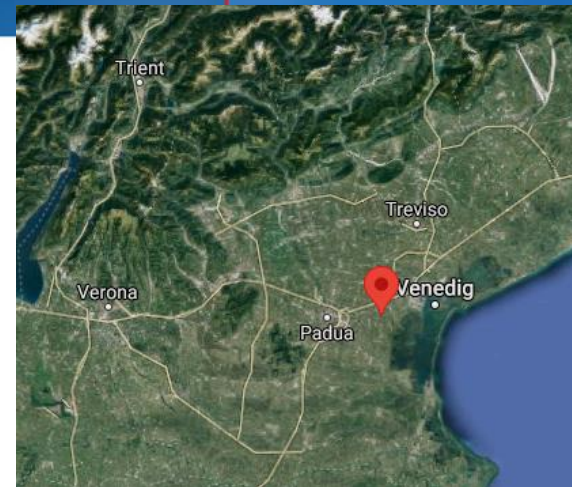
Case 1: F4-Tornado Mira/Dolo (VE), Italy, July 8th, 2015 (1/4)

- July 8th, 2015, 17:25-17:45 CEST
- Affected communities: Baluello (Pianiga) Arino (Dolo), Pianiga (Cazzago), Cazzago, Dolo (San Bruson), Mira, Porto Menai (Mira), Piazza Vecchia
- Length of damage path: 11 km
- Mean width of damage path: 700 m
- Maximum width : 1000 m
- Maximum intensity: F4 (335-421 km/h), violent
- Number of fatalities: 1 (person was forced to stop car because of electric mast blocking the road, then car was picked up by the tornado)
- Number of injuries: 72
- Damage: about 100,000,000 EUR
- Accompanying hail: 5 to 7 cm

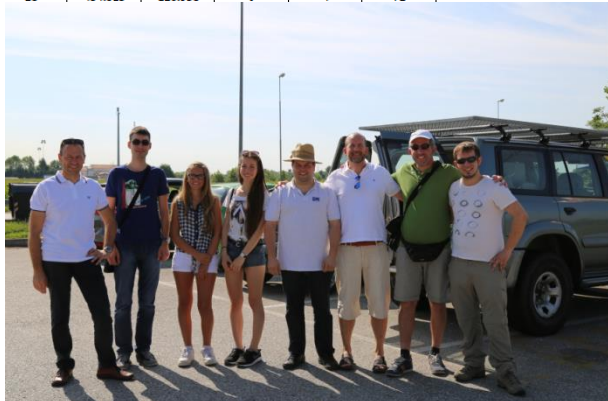
Attachment 2: List of damage ratings

120 data points (mostly buildings) with intensity ratings or other relevant information and hundreds of damage photographs.

14	454.437	120.665	F	1	F2+		metal roof cover blown away
15	454.432	120.643	J	2	F1+	90	uprooted tree
16	454.427	120.643	J	2	F1+	180	iron fence, trees fell towards S
17	454.415	120.645				90	debris, waste containers
18	454.421	120.671	B	3	F2-	270	broken concrete wall
19	454.411	120.671				180	mais/corn bent
20	454.404	120.671	E	1	F2-		
21	454.391	12. Jul	E	1	F2-		
22	454.392	12. Jul	C	2	F2-		
22a	454.392	12. Jul	E	1	F2-		
23	45.441	12.074	E	0	F1-		
24	454.393	120.742	E	1	F2-		
25	454.355	120.748	E	1	F2-		
26	454.337	12.075	E	0	F1-		
27	454.286	120.909	J	4	F2		field of young trees snapped
28	454.315	120.958	J	4	F2		large tree

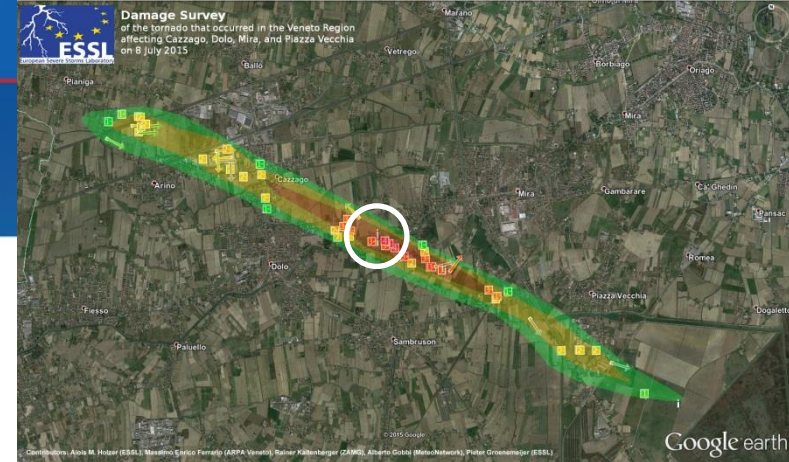
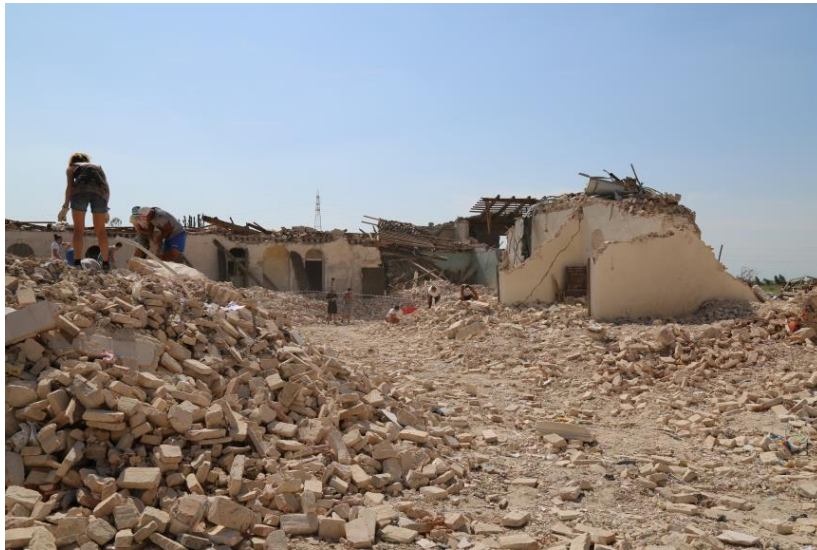
The western neighborhoods of Mira experienced the worst tornado impact. A few buildings were rated F4, including the historical Villa Fini. This villa was assumed to be a “weak brick building” damage indicator because of the very aged and crumbly mortar in between the bricks. This building totally collapsed.

Remnants of Villa Fini (F4, collapsed weak brick structure) in western Mira (photo: Alberto Gobbi)

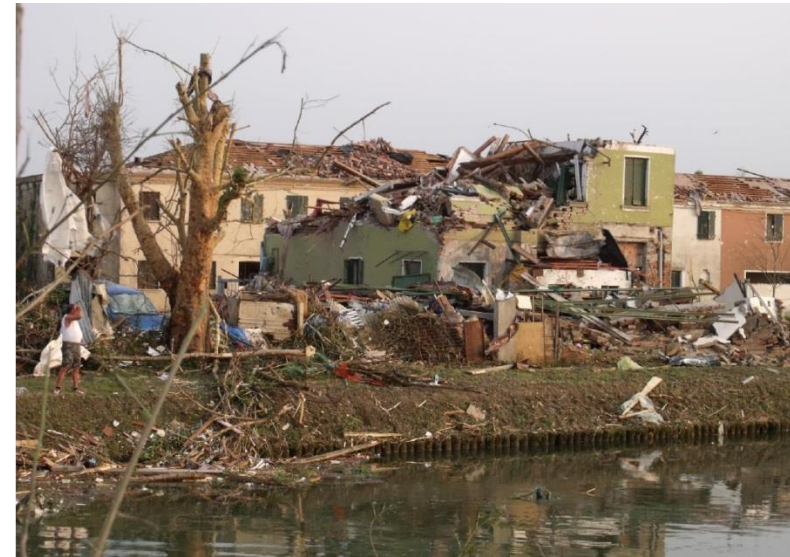
F4 damage (strong brick structure, walls partly collapsed) in western Mira close to the Villa Fini, on the other side of the streamer (photo: Alberto Gobbi)

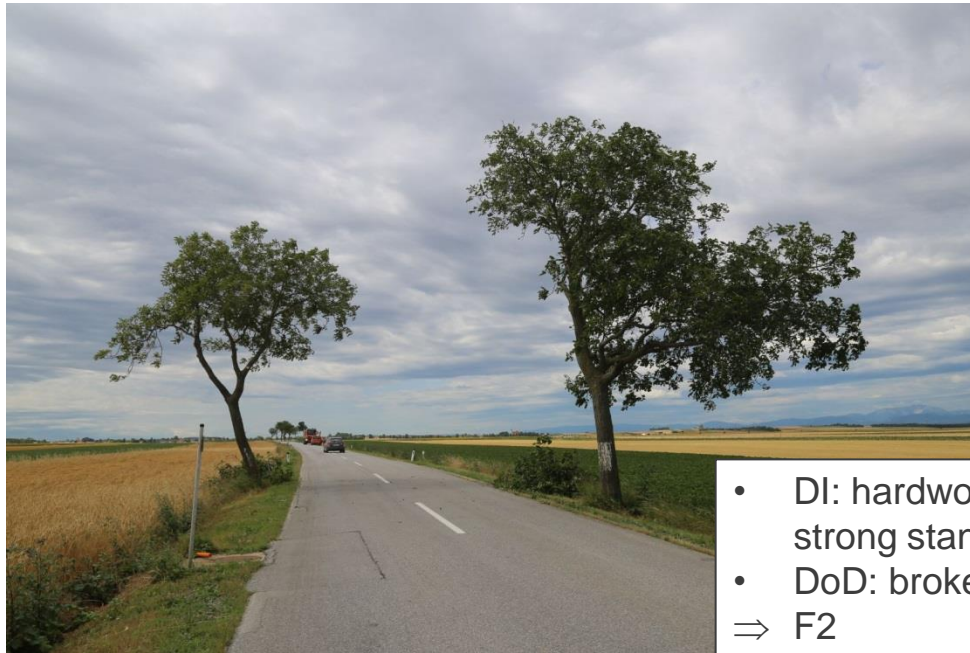
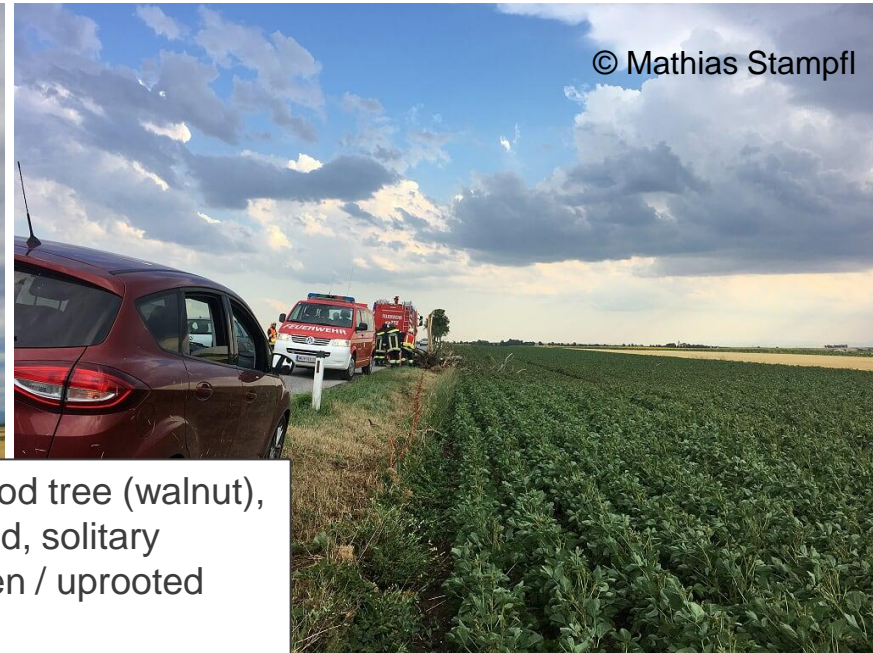
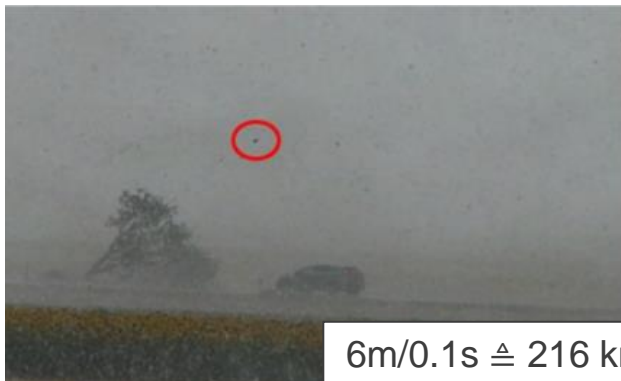
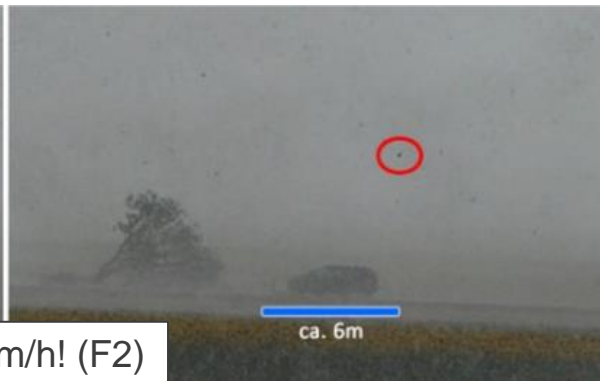
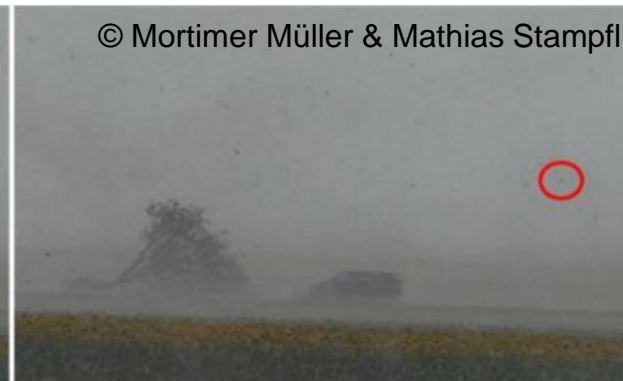
Damage Indicator: Alley trees next to L2063 road

- DI: hardwood tree (walnut), strong stand, solitary
 - DoD: broken / uprooted
- ⇒ F2

6m/0.1s \triangleq 216 km/h! (F2)

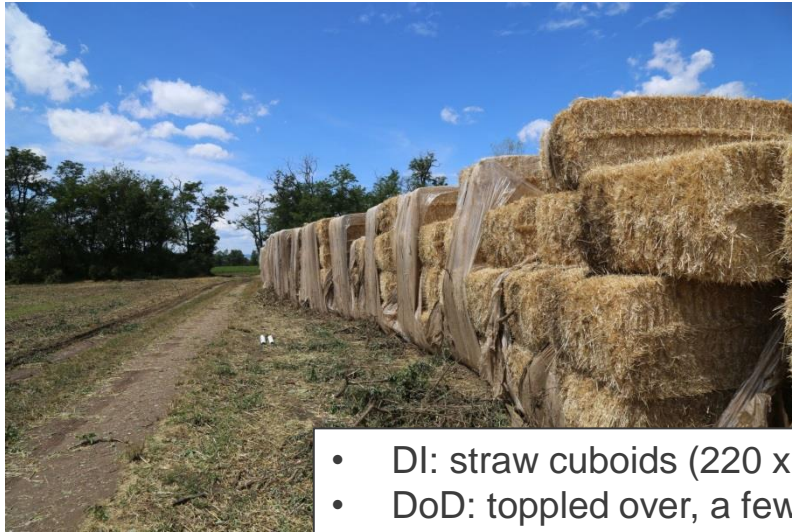
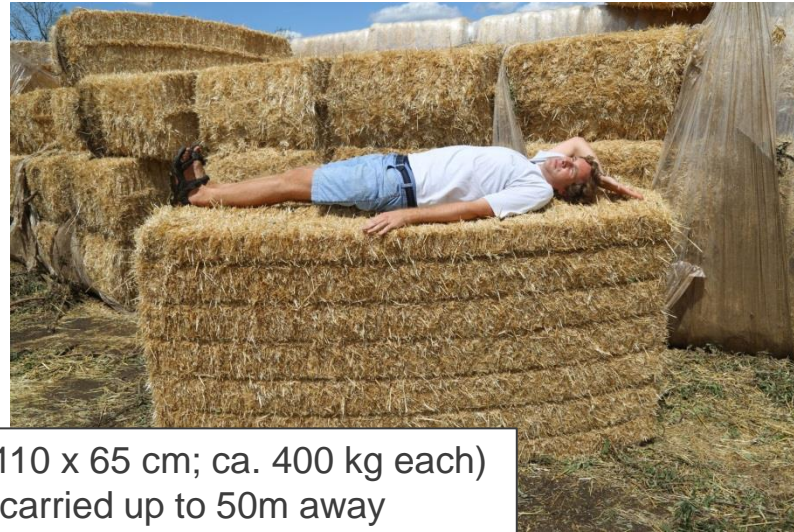
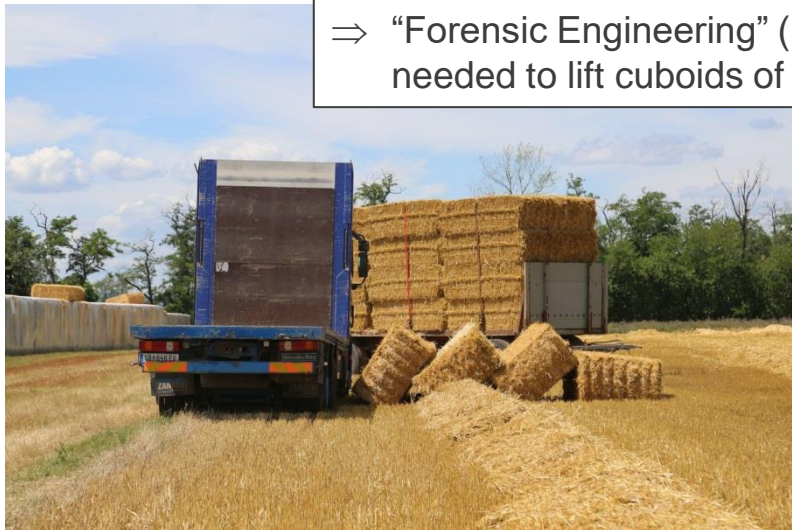
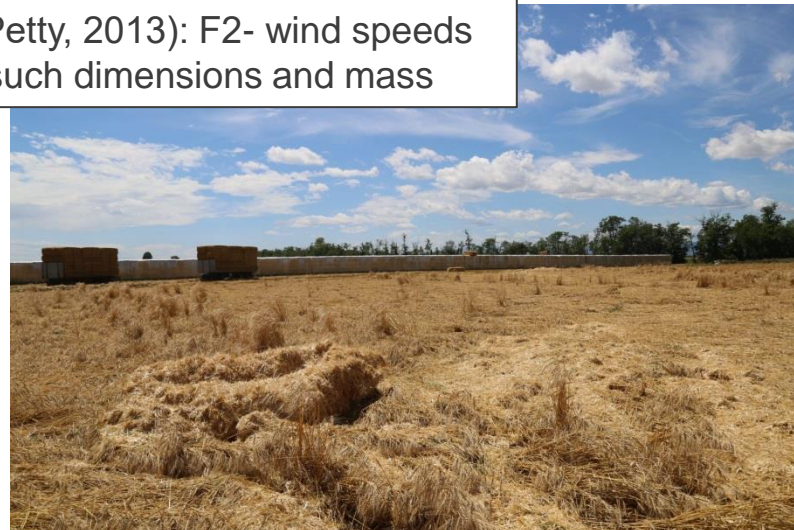
Damage Indicator: wall of straw cuboids

- DI: straw cuboids (220 x 110 x 65 cm; ca. 400 kg each)
 - DoD: toppled over, a few carried up to 50m away
- ⇒ ???
- ⇒ “Forensic Engineering” (Petty, 2013): F2- wind speeds needed to lift cuboids of such dimensions and mass
